STORMWATER MANAGEMENT REPORT

NAPLES MARINA PROPERTY NAPLES, MAINE

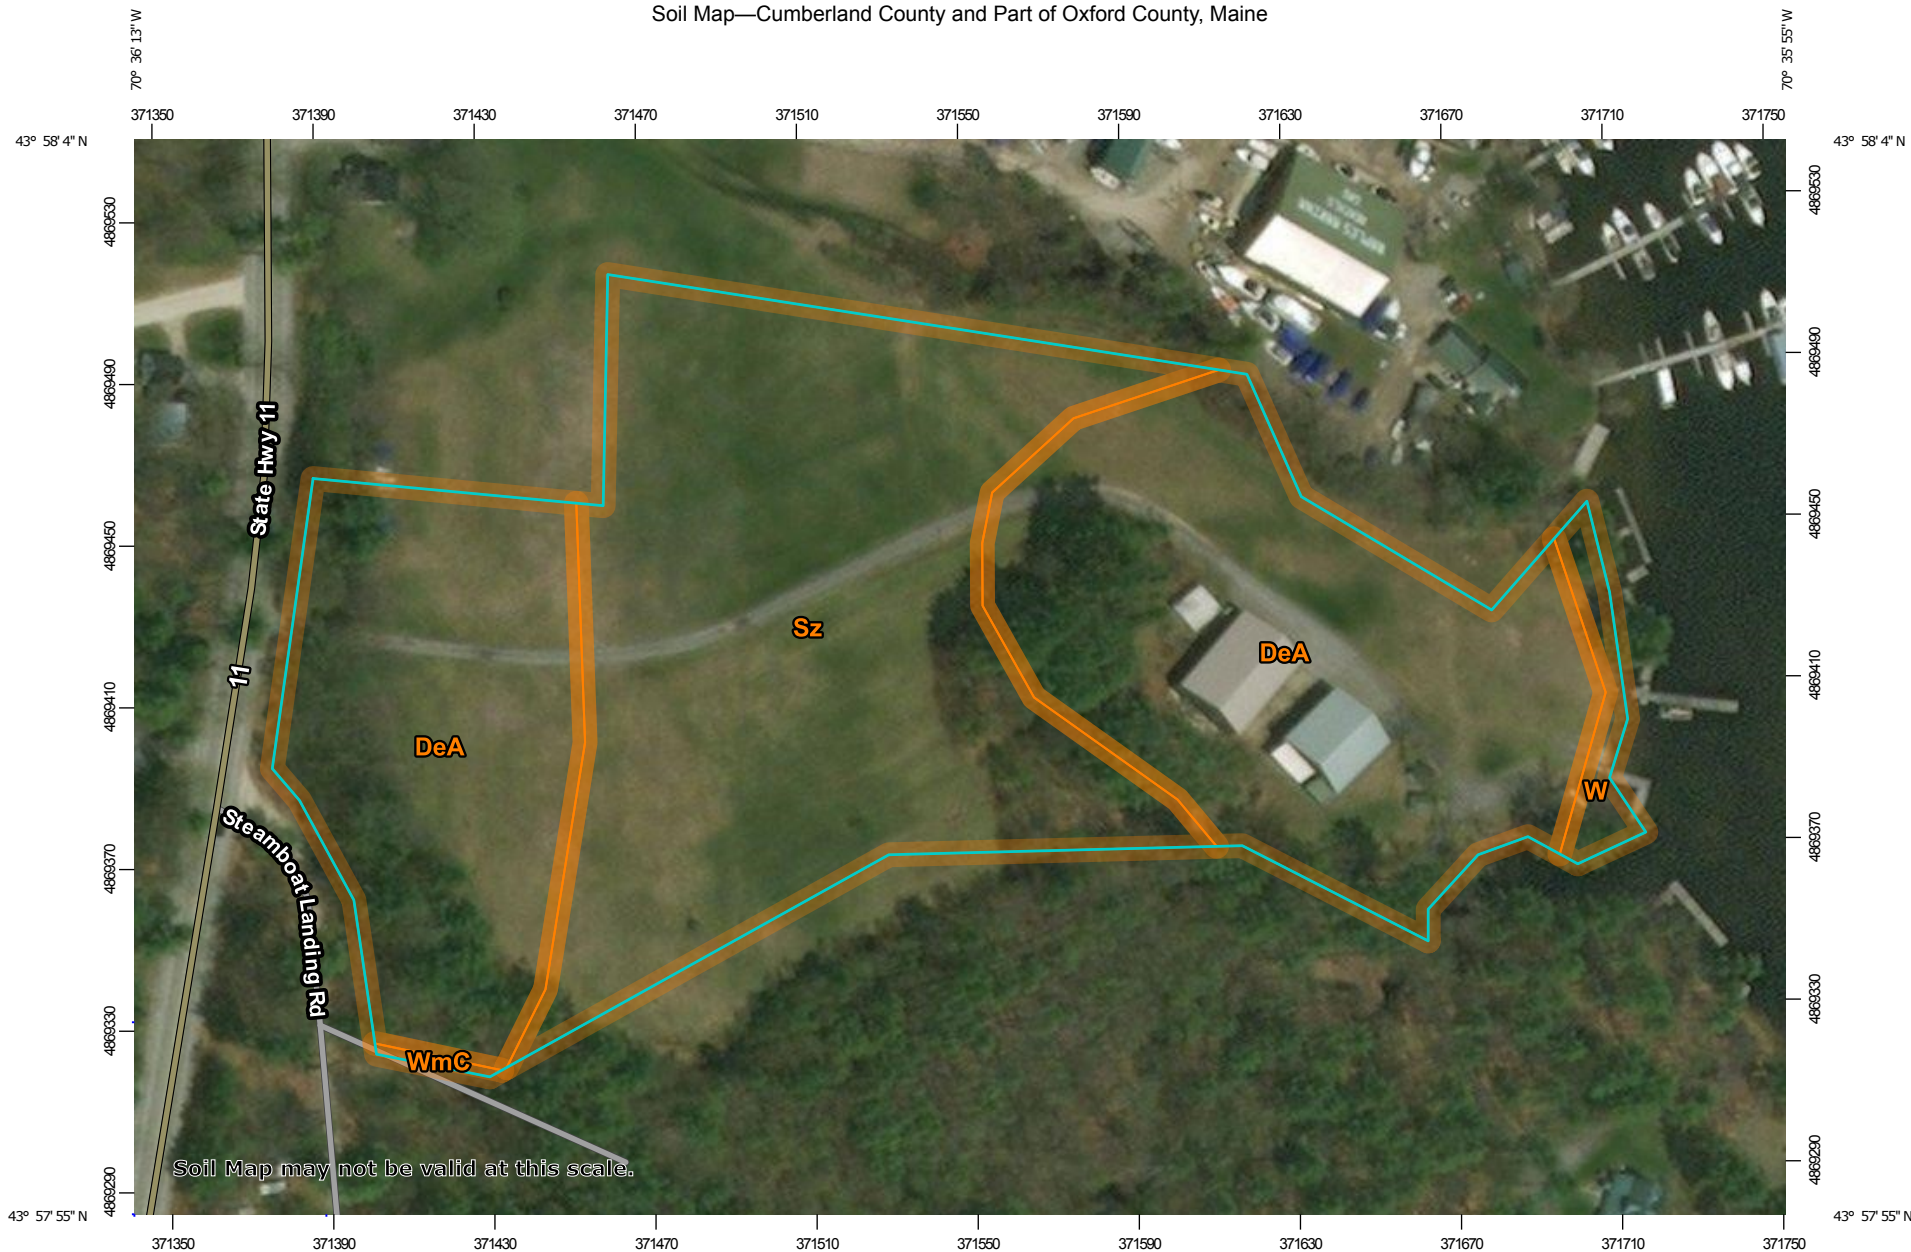
Soil Map—Cumberland County and Part of Oxford County, Maine

SOILS MAP

Soils classification on the property were obtained from the Medium Intensity Soil Maps for Cumberland County, Maine published by the Natural Resources Conservation Service. On-site soils are classified as Deerfield loamy sand, which is a moderately well-drained soil with a hydrologic soil group "A" designation, in the areas around the existing and proposed buildings, and along Route 114. Approximately 4.5 acres in the center of the property (the field area) is classified as Swanton fine sandy loam, which is more poorly drained than the Deerfield soils. The soils on the property are generally suitable for the proposed development.
